PUBLIC WORKS DEPARTMENT

# DOWNTOWN PARKING STRUCTURE CONDITION ASSESSMENT

Lots 2, 6, 7, 10, 11, and Depot Lot Structures

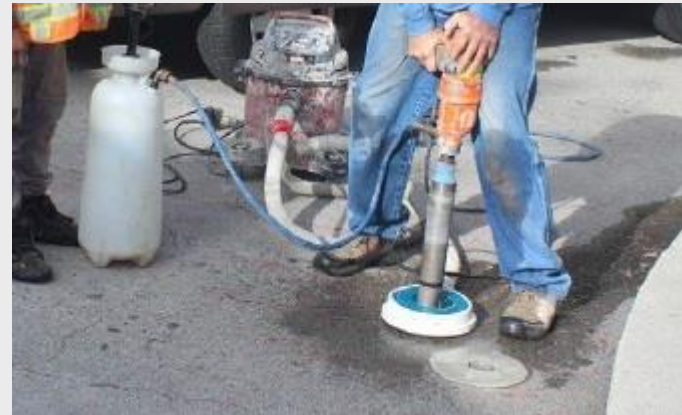
- Concrete coring
- Testing for Chloride Content and strength of concrete

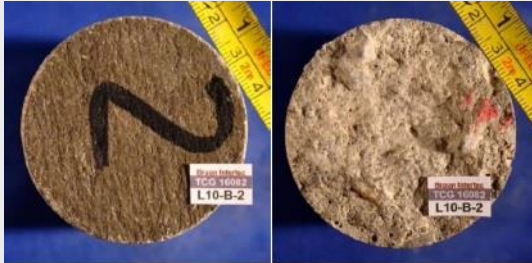
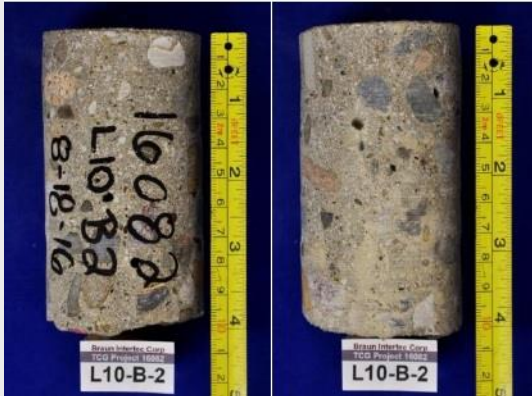
14a. Top (left) and bottom (right) ends of the core, as received.

- Typical core sample
- Strength of concrete determined by fracturing cylinders
- Concrete determined to be in generally good condition

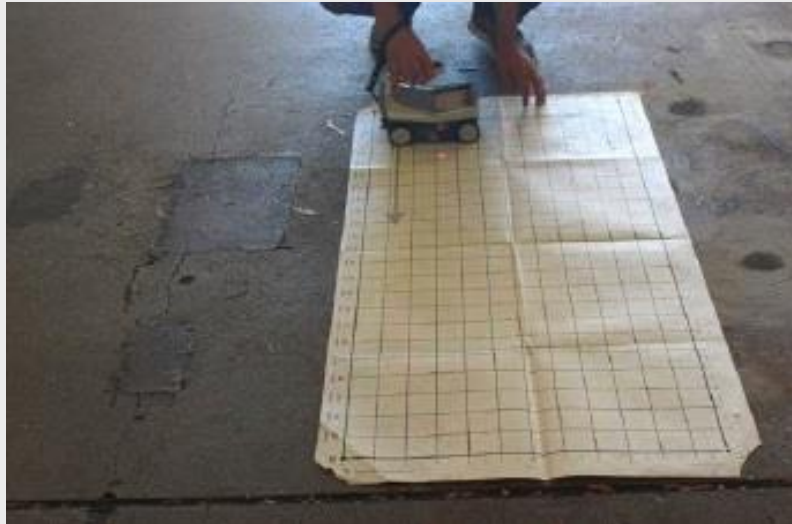
- Ground Penetrating Radar
- Used to identify density of concrete and location of rebar

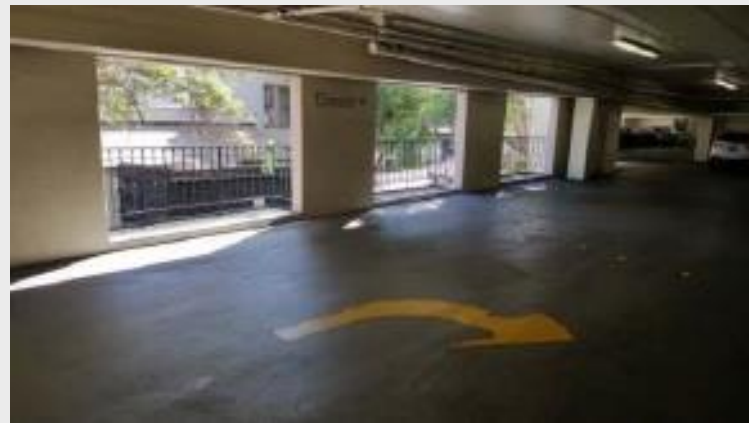
- Existing balcony rails are not vehicle rated
- Balcony rails do not meet pedestrian guardrail requirements
- Crash tested barrier rails recommended

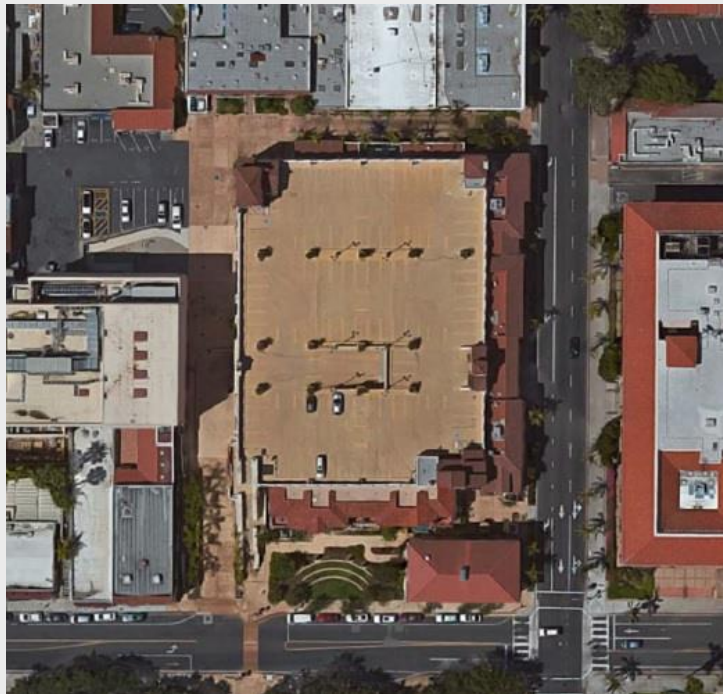
- Minor repair items
- Structure in very good condition
- Only 10 years old

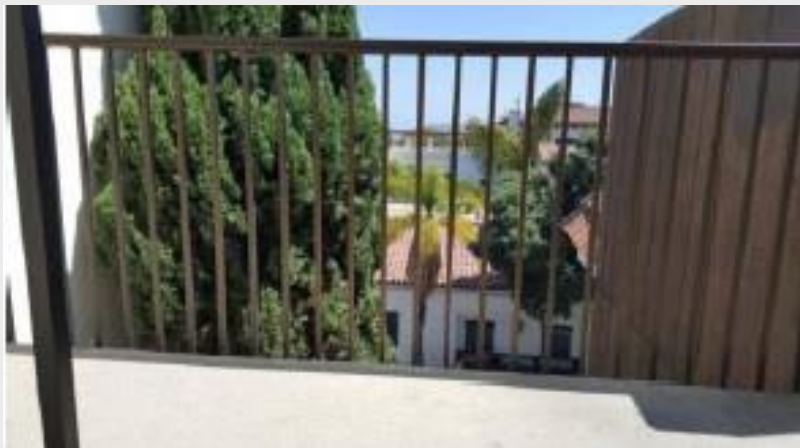
- Some railings were previously retrofit to meet standards

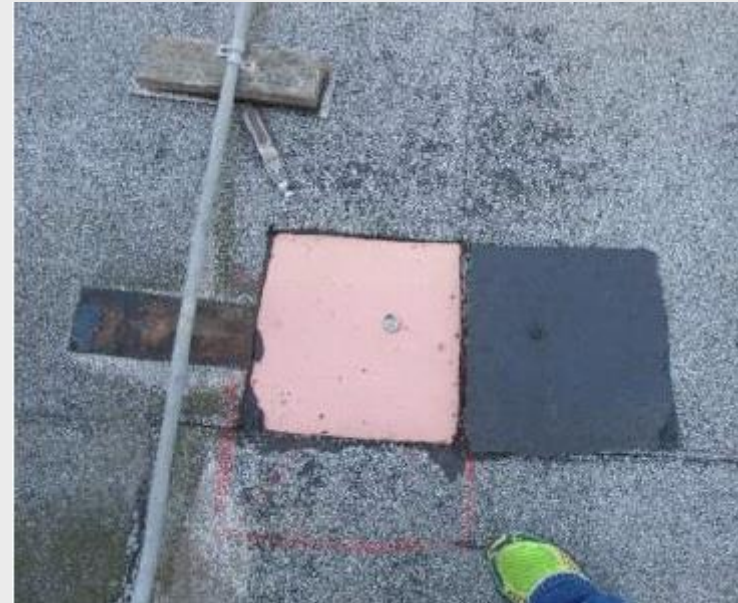
- Exploratory Openings
  - Carefully opened portions of the built-up roof on the Amtrak Building
  - Examined condition of underlying material

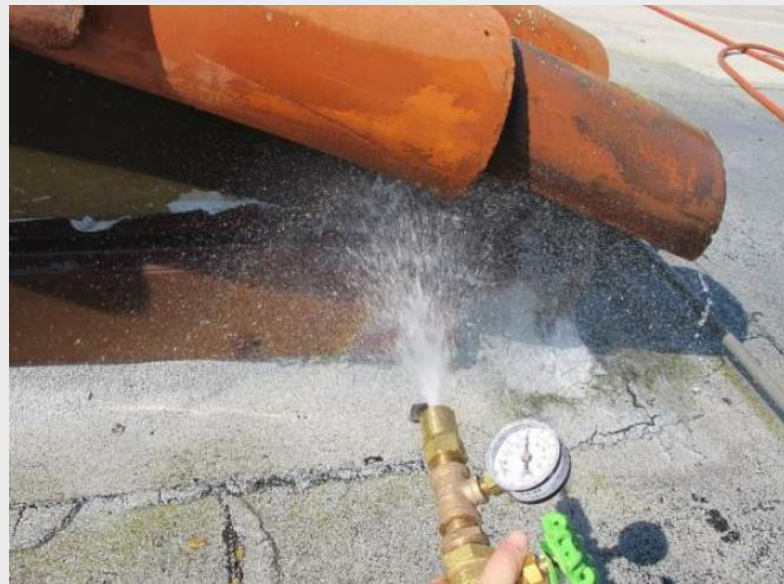
- Water testing
  - Nozzle directed water at surface interfaces, observing intrusions over a 15 minute sustained duration

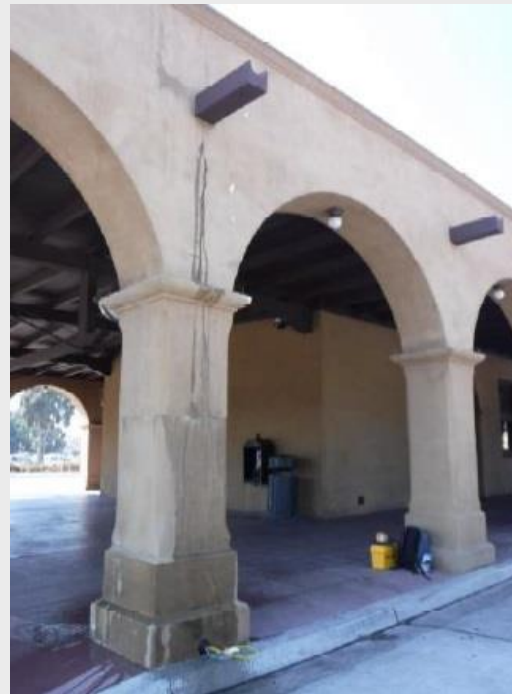
- Water intrusion testing in column at Amtrak Building

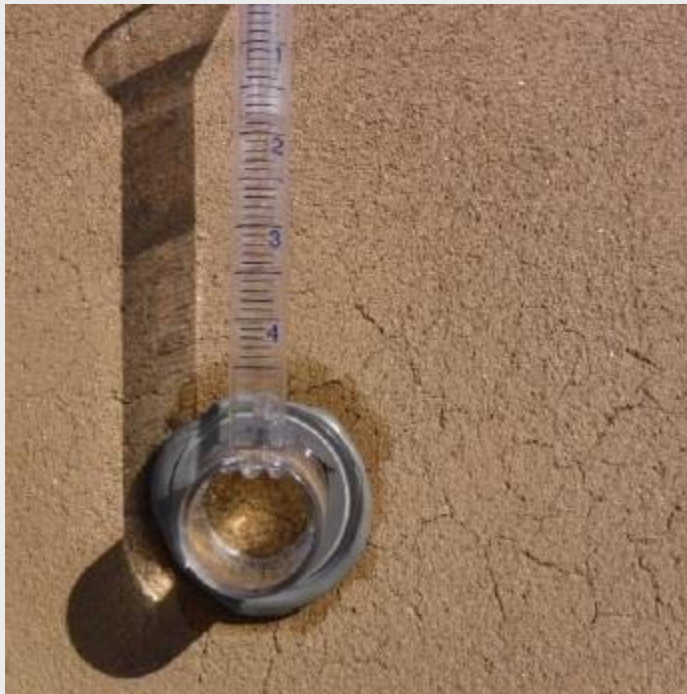
- Low water absorption in walls
- Plaster in overall good condition

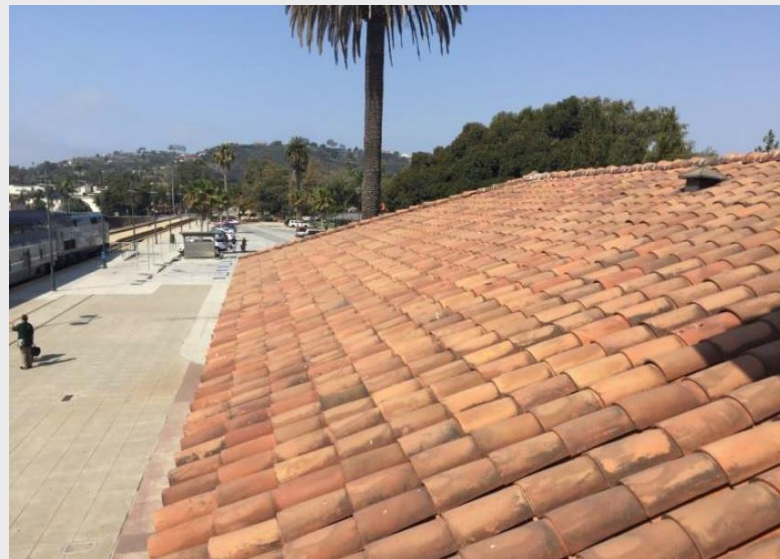
- Clay Tile Roofs generally in good condition
